Photo Attachments

Common Defects

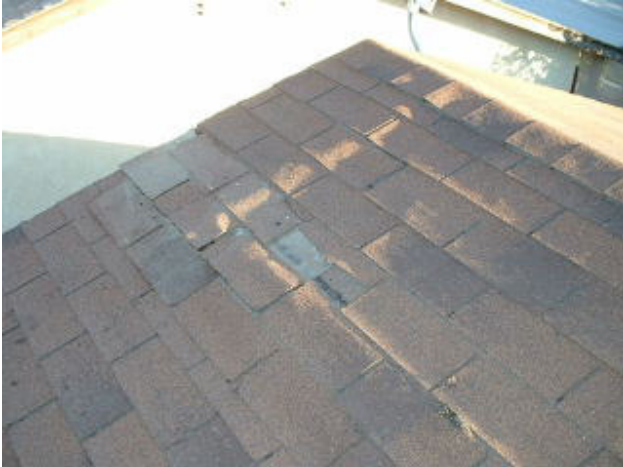
Damaged roof shingles. Improper roof shingle installation; improper overlapping. Improper layout.

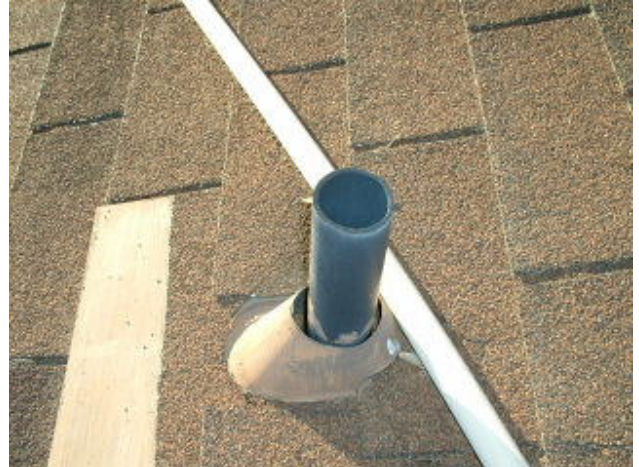
Improper flashing at plumbing vent stack. Wrong size jack. No storm collar.

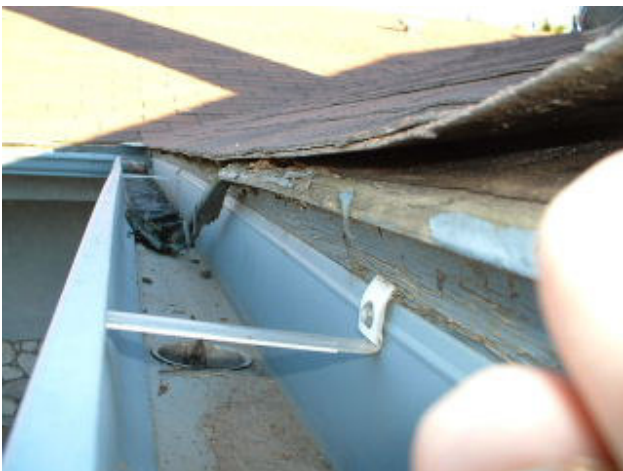
Improper installation of roof underlayment paper; felt paper does not extend out over edges of roof sheathing. This resulted in wood rot.

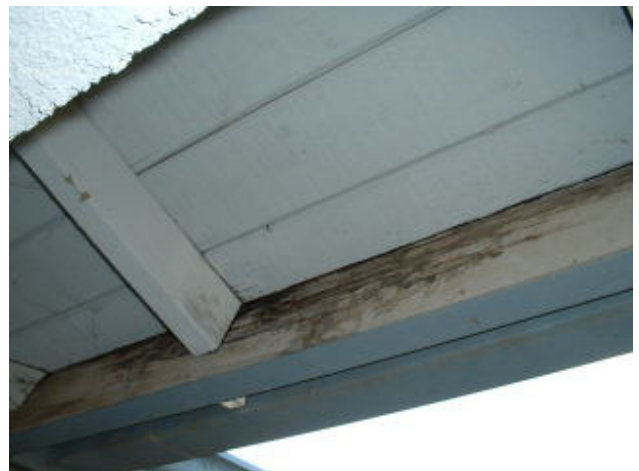
At underside of roof eave, the fascia board was damaged due to improperly installed underlayment paper

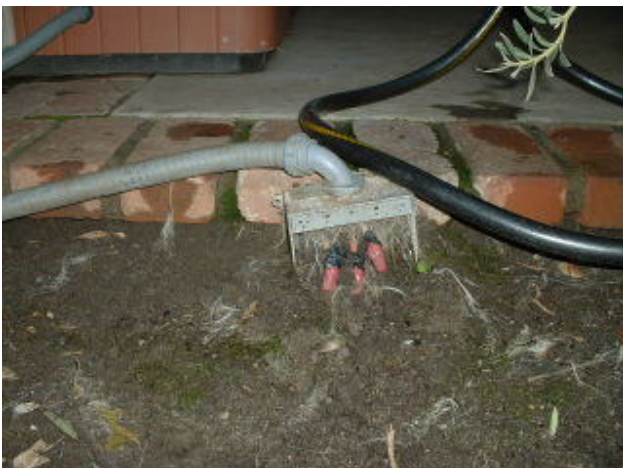
Electrical junction box for Spa was missing cover and was buried in soil.

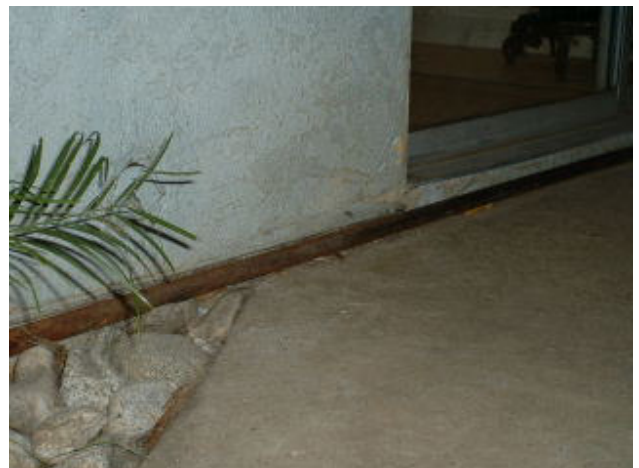
Auxiliary Gas pipe not elevated at least 6" above grade. Also, inappropriately installed under weep screed of stucco siding. Also, in front of toe kick at patio door.

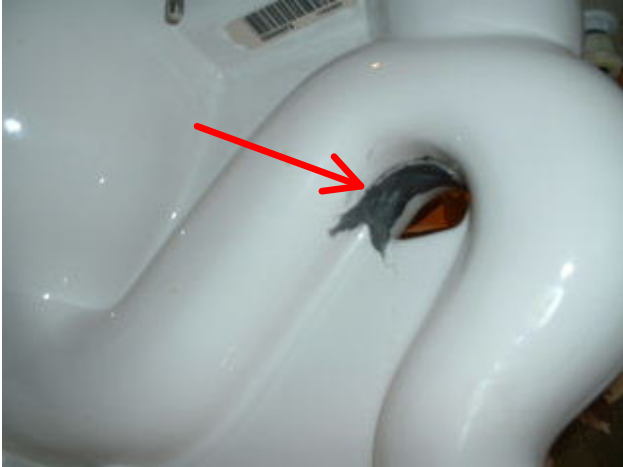
Rear of toilet trap was cracked and patched by "someone" with some type of epoxy. It was leaking at time of inspection.

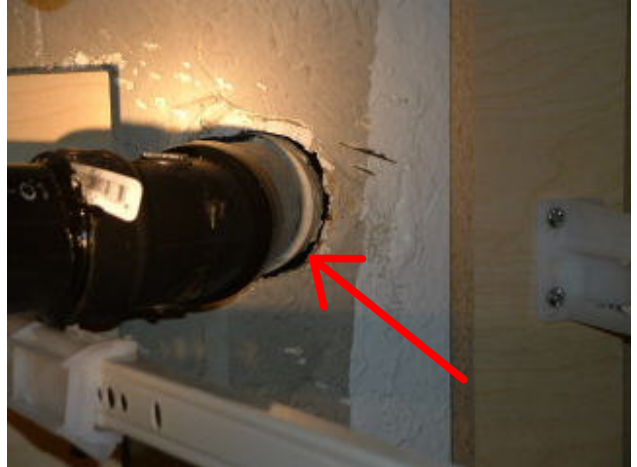
Wall under bathroom sink was not sealed at plumbing drain pipe penetration.

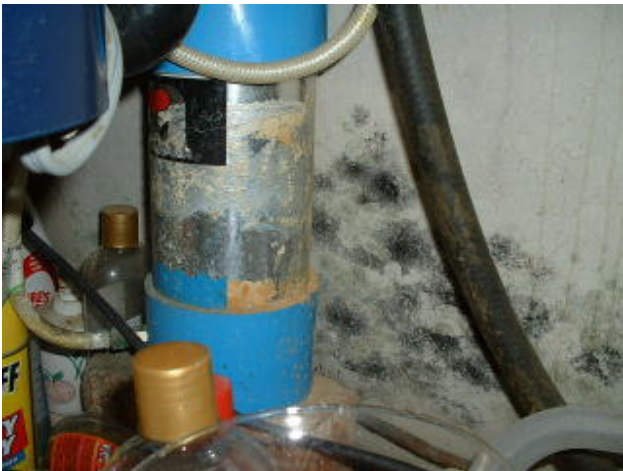
Moisture/Mold damage at wall under Kitchen sink.

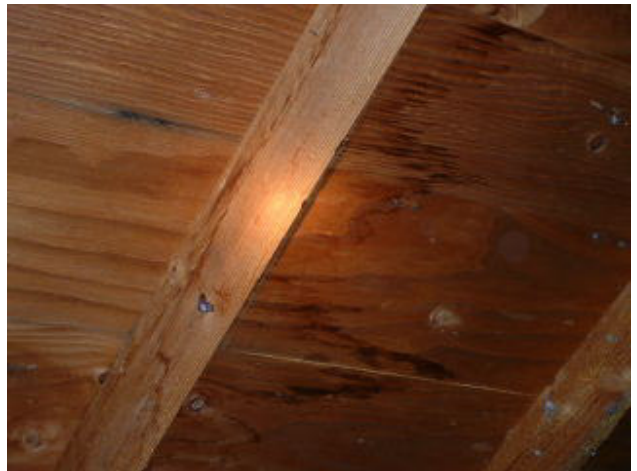
Water damage at under side of plywood roof sheathing due to roof leaks.

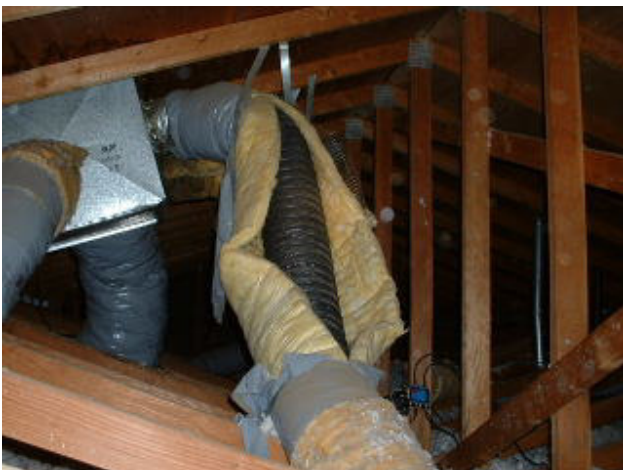
Damaged ductwork in attic common to ductwork manufactured at this time, particularly when exposed to sunlight through attic vents.

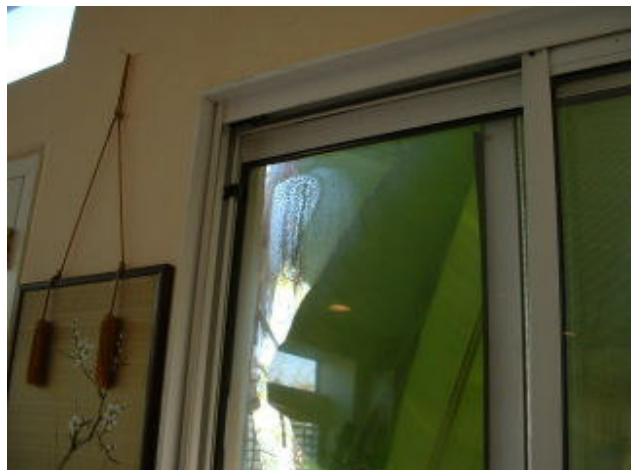
Failed thermal window has condensation between panes and needs to be replaced.

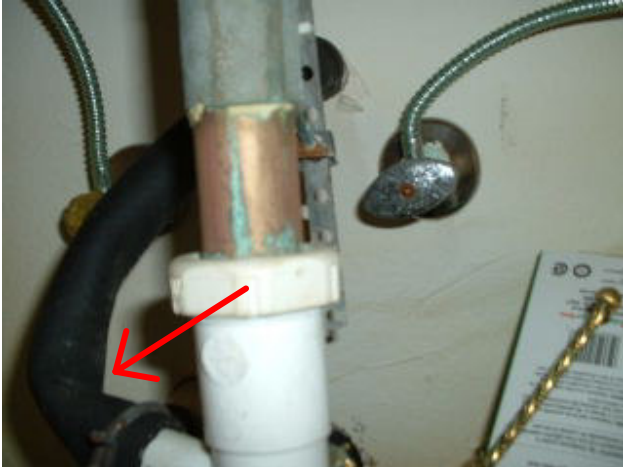
Air conditioner condensate drain hose is kinked under sink. Drainage was blocked.

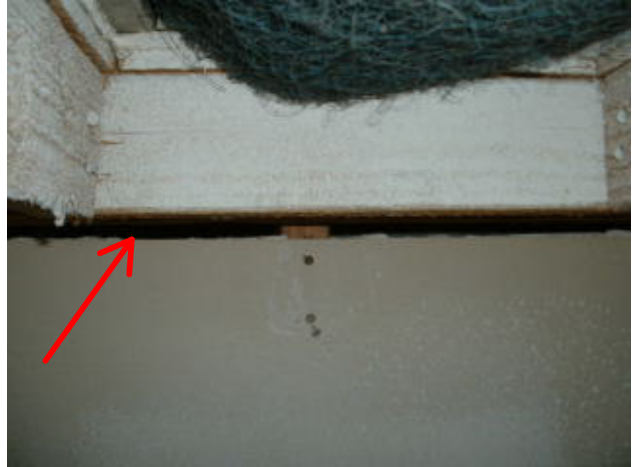
Open gap at plenum wall, under furnace.

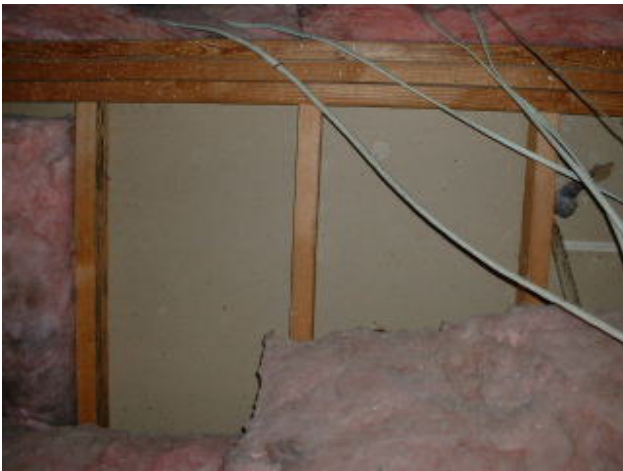
Insulation has fallen down from interior walls in attic.

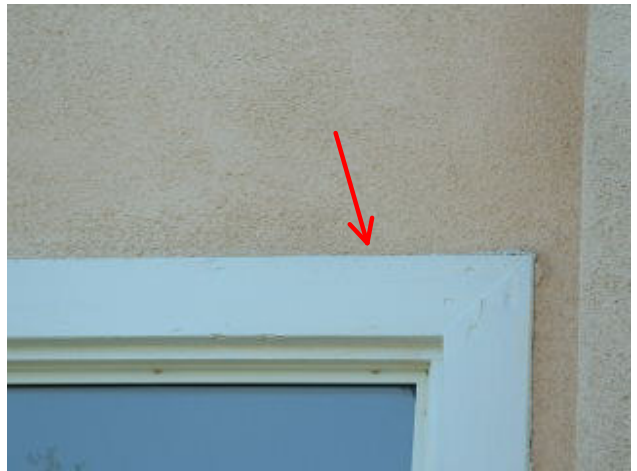
4 year old house: Missing drip cap flashing at exterior above window. Resulted in water intrusion at interior.

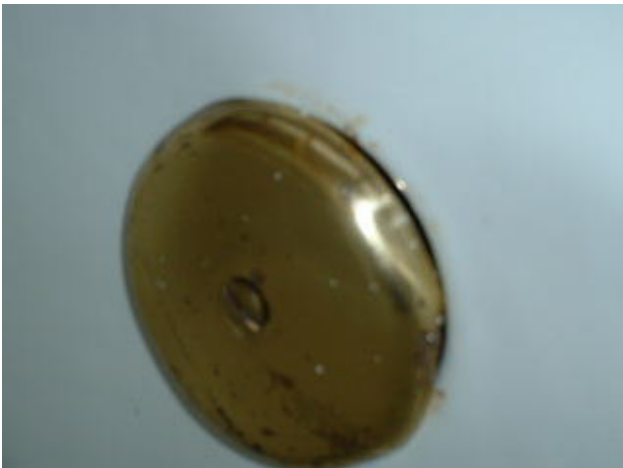
Loose & misaligned Tub overflow plate. Substantial potential for leaks.

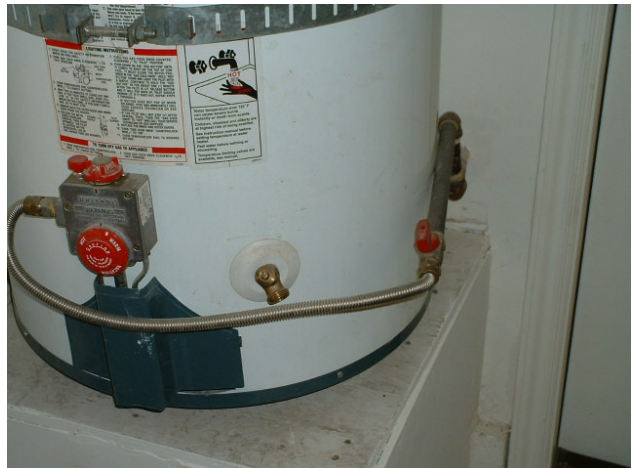
Water heater installed against gas pipe. Strained gas pipe. // No overflow pan.

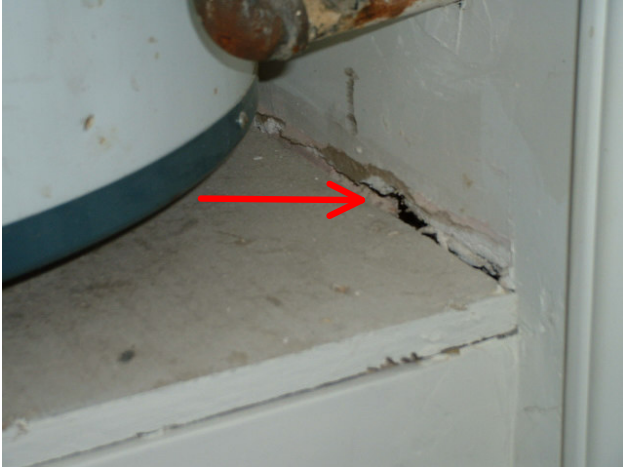
Gap between water heater platform and firewall of garage.
Breach in firewall.

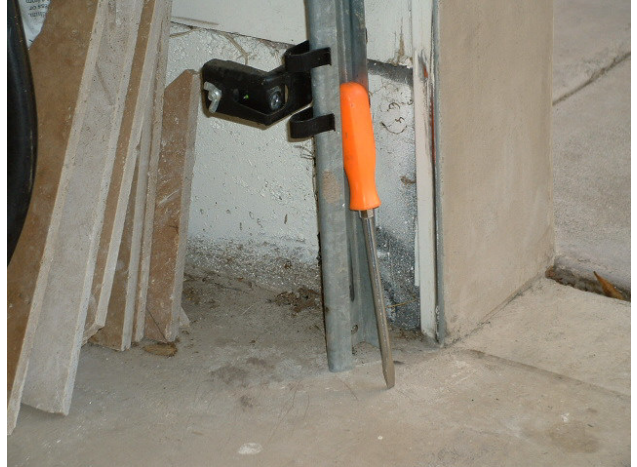
Photo-electric sensor for garage door is more than 6" above the floor and is a child-safety hazard.

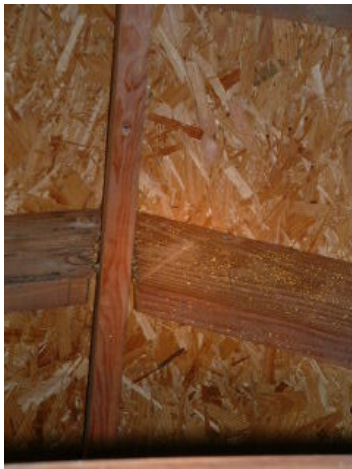
Rafters are separating from ridge board due to excessive structural movement.

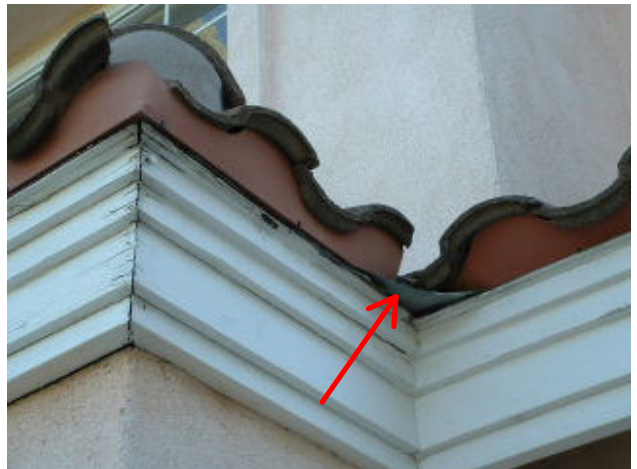
15 year old house: Valley flashing is 16" wide and should fully extend out from under roof tiles. Note resulting water damage at fascia at left side corner.

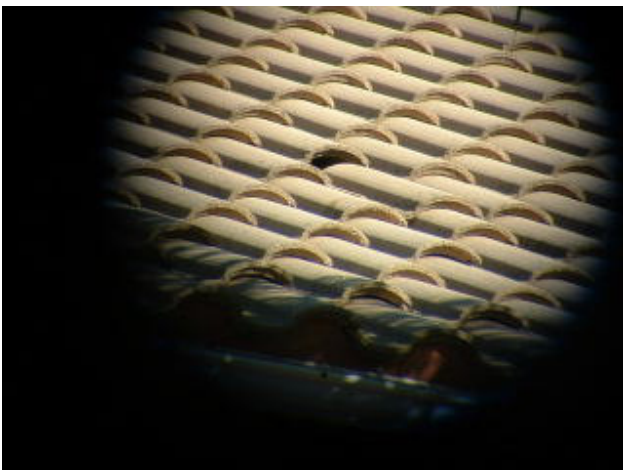
4 year old house: Example of a slipped roof tile from improper installation. More to come.

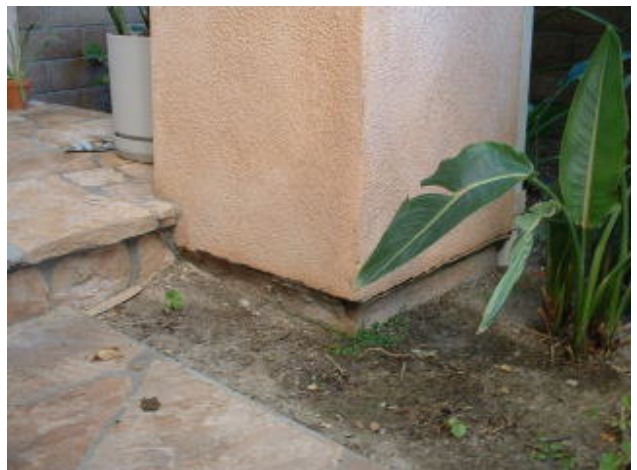
Stoop was built up over weep screed. Sprinkler spray on structure. Resulting in corroded weep screed. Eventual replacement will be needed.

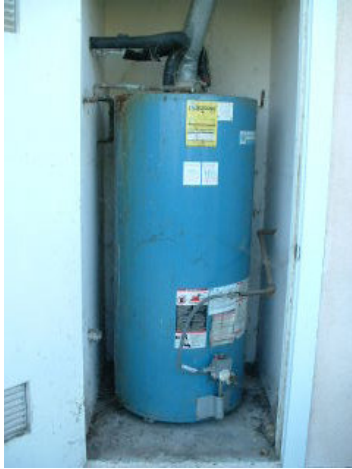
Improperly installed water heater. No seismic straps. Old brackets screwed to top of tank. No overflow pan. Corroded, leaking tank.

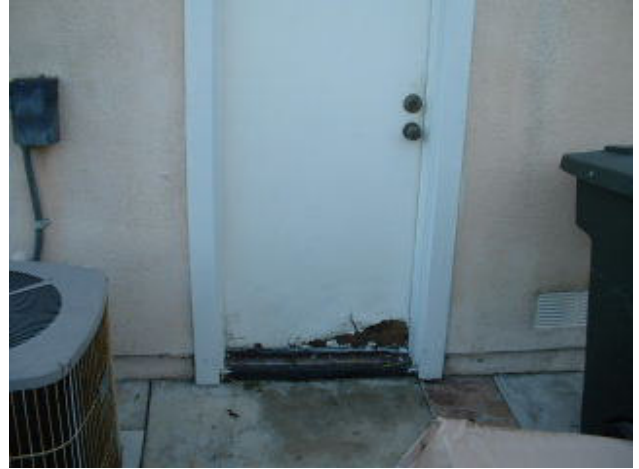
Electrical disconnect box improperly located behind A/C condenser unit. // Excessive wood decay to exterior service door of garage. // Good clearance from weep screed.

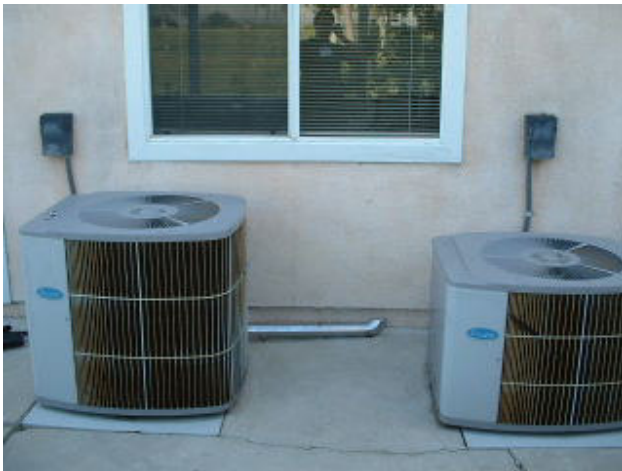
Concrete walk was poured around base pads of A/C units. Units should be elevated 3" above grade. // Units not secured in place. // Right electrical box behind unit.

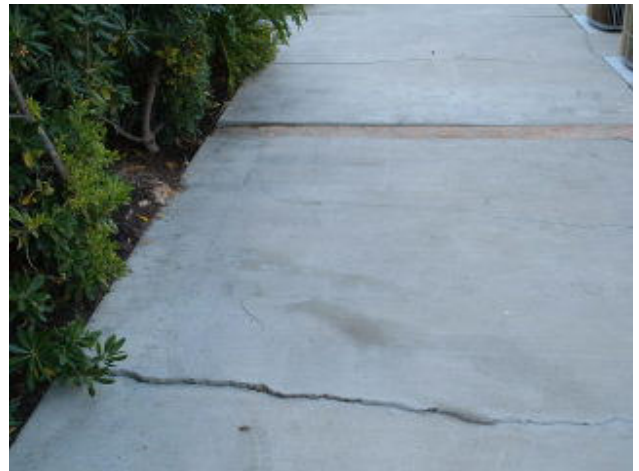
Cracks and uneven settlement in walkway are trip hazards.

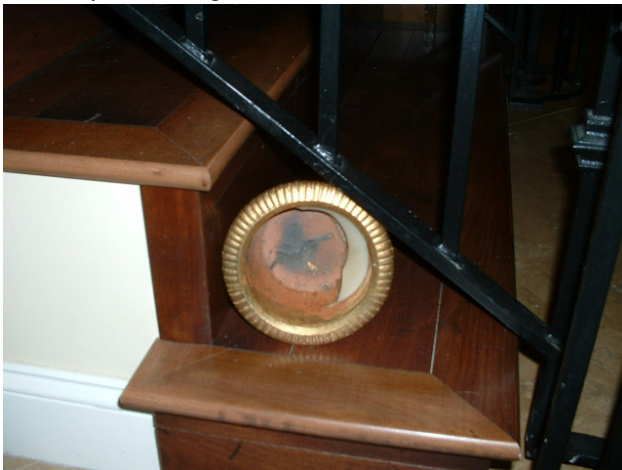
3 year old house. Improper railing construction. 6" sphere should not pass through triangle formed between rail, riser & tread. Child safety concern.

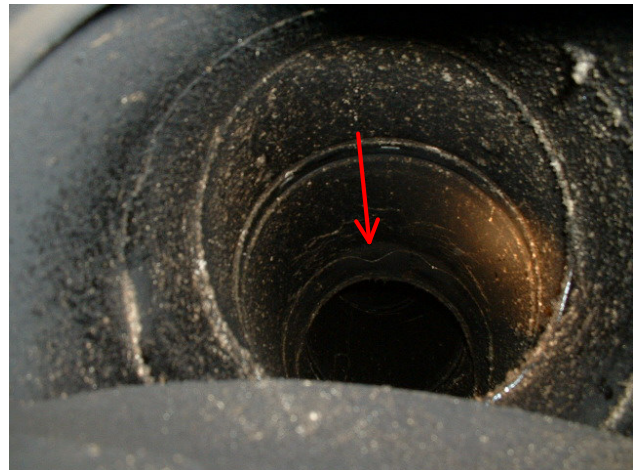
Excessive creosote in fireplace from burning real wood. Fire safety concern. Requires cleaning. // Bent sheet metal at joint seam in flue. Safety concern.

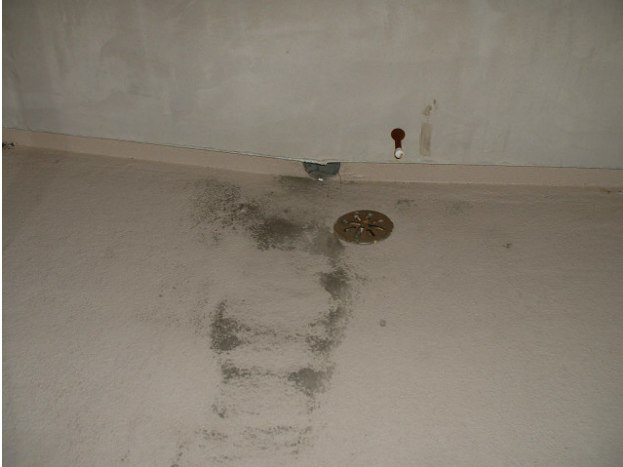
Overflow at deck is below primary. Water bypasses main drain and splashes onto walkway 2 stories below. Primary drains to street, but will not function properly.

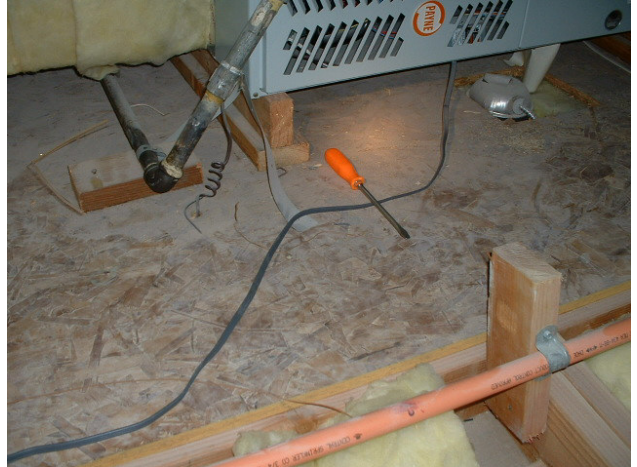
Improper access/clearance at furnace. Requires 30" deep floor (Screwdriver is 10"). Gas pipe, power cord & Fire sprinkler pipe are in the way & subject to damage.

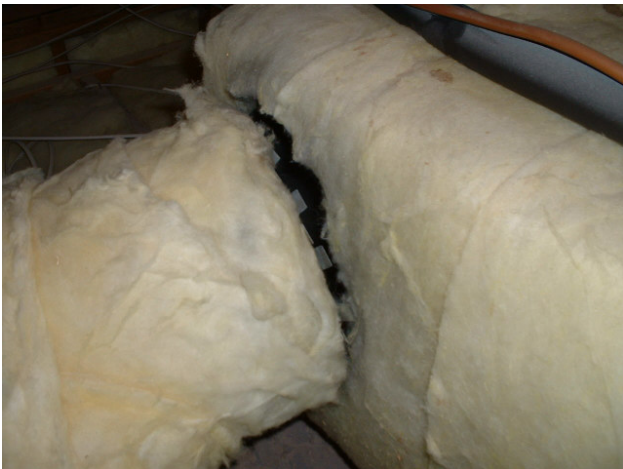
4 year old house: Improperly installed duct at air handler became nearly detached.

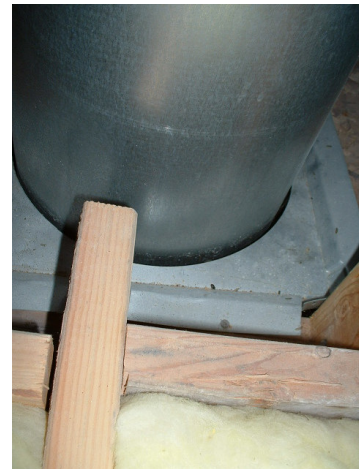
3 year old house: Improper installation and/or fit of the firestop at the fireplace flue as viewed in attic.

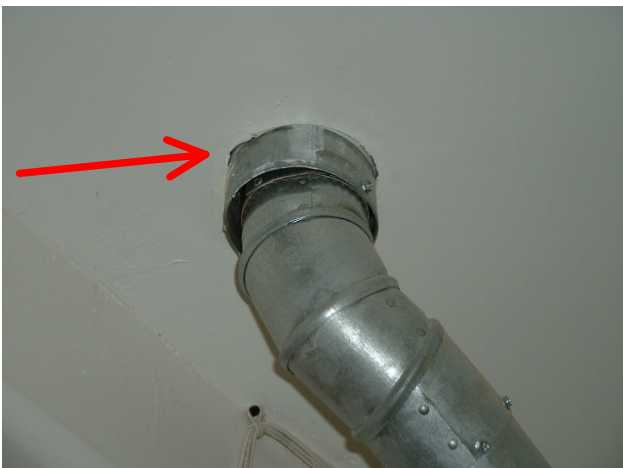
3 year old house: No firestop bucket/thimble installed for water heater vent at garage ceiling penetration. Fire safety concern.

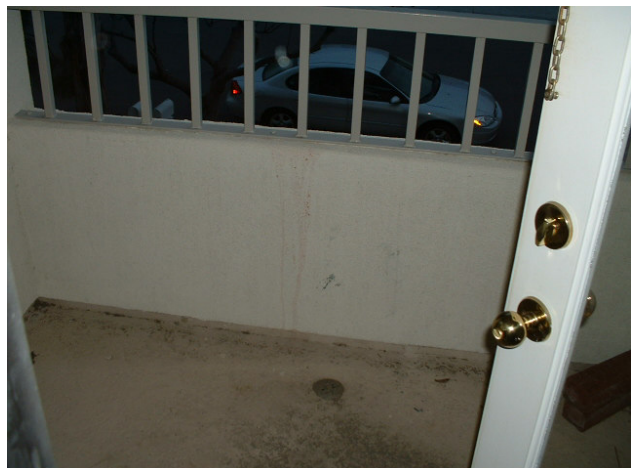
No overflow drain. // Short wall provides foothold for small children to climb up. While not a specific violation, common sense would dictate precautions.

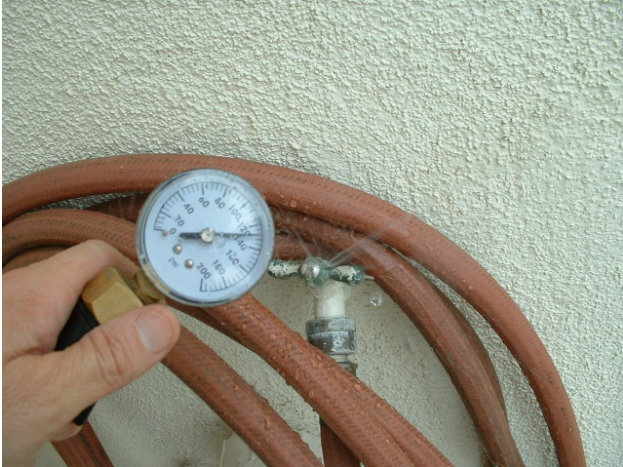
Excessive water pressure, nearly 130 psi. Valve stem leaks. No backflow preventer.

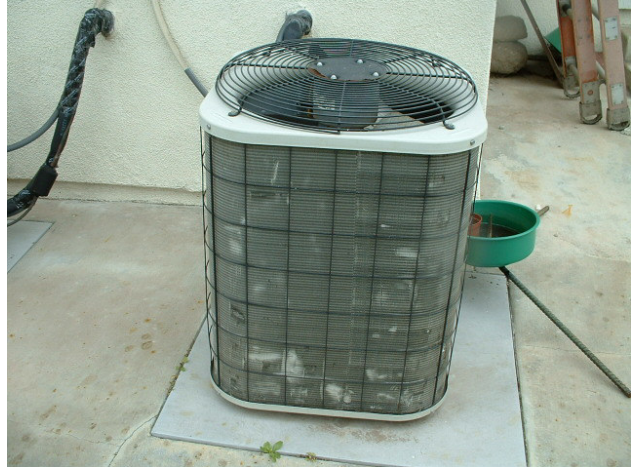
AC compressor/condenser unit is not elevated 3" above finished grade level and not secured in place. Dented heat dissipating fins. Fins are starting to disintegrate.

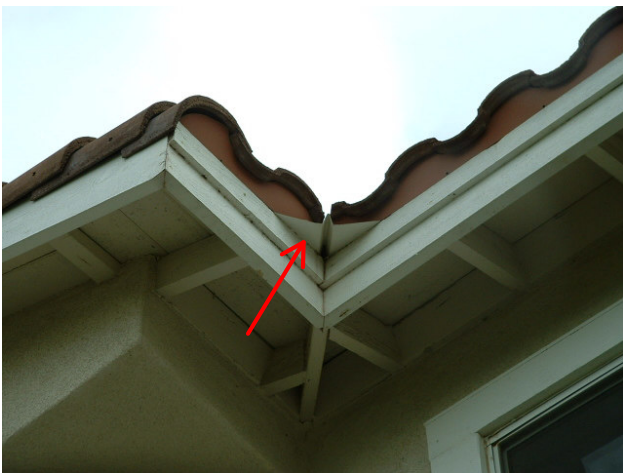
Valley flashing is 22" wide. The flashing should extend out from under the tiles and over the edge of the fascia. Only about 6" width is visible. Will lead to water damage at Eave.

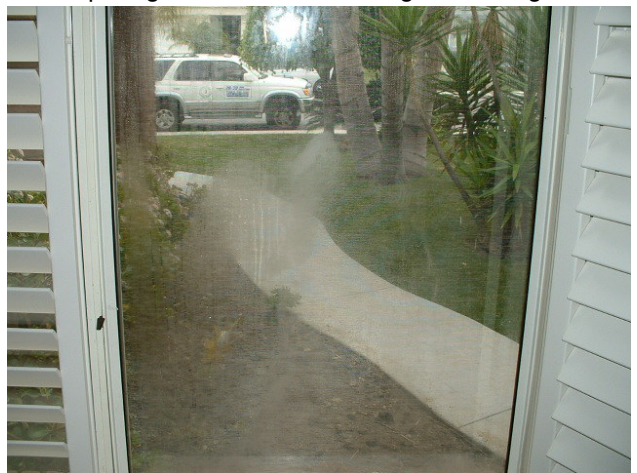
Failed thermal window has condensation between panes and needs to be replaced.

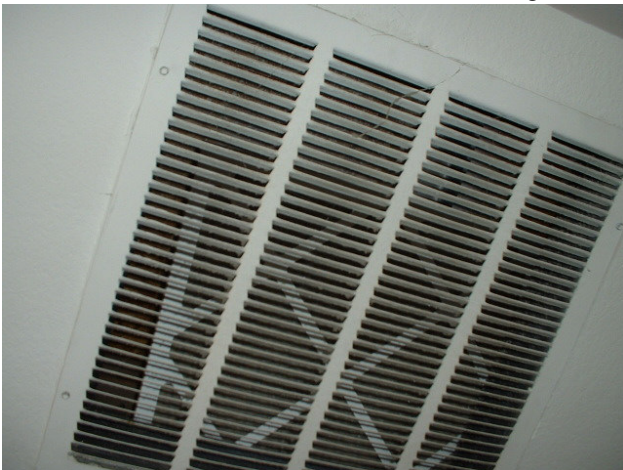
Filter inappropriately installed at a ceiling return-air grill where there is no filter provision. Filter is displaced because there is no retention system.

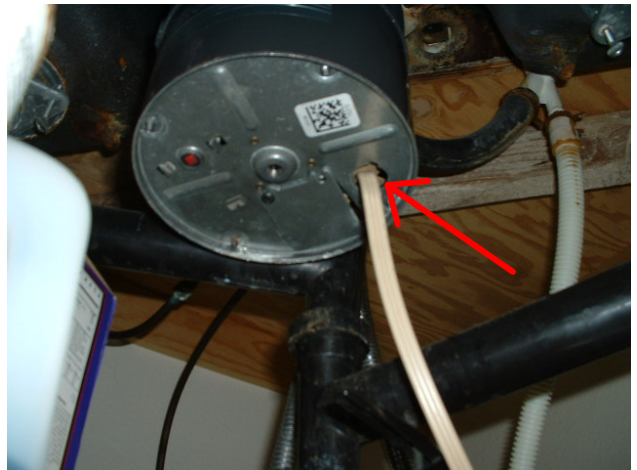
Missing strain relief cable bushing at disposal. Electrical connections can be pulled on.

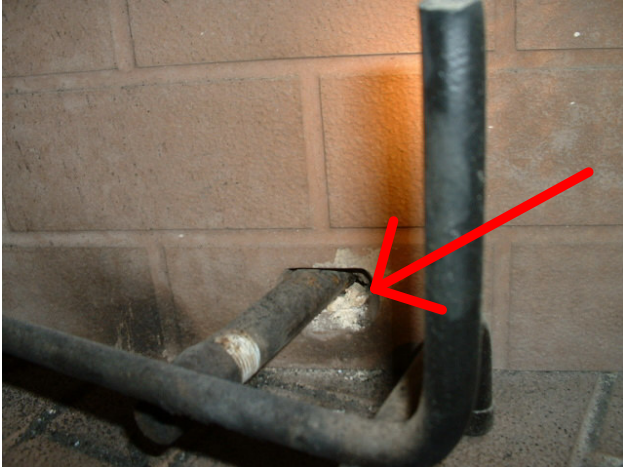
Missing fireproof grout at Fireplace wall. This needs to be sealed to prevent gas, fire, smoke & embers from entering wood structure. Minor repair.

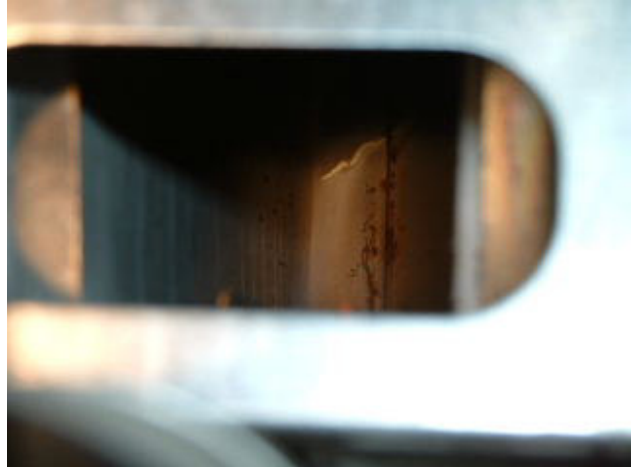
Cracked heat exchanger in Furnace. Life safety concern due to carbon monoxide. Furnace requires replacement.

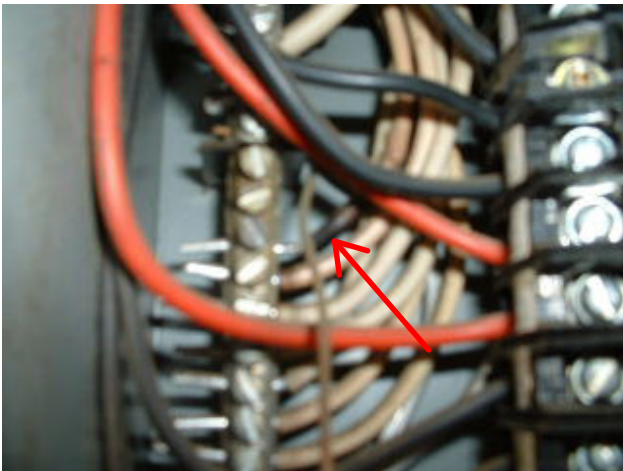
Aluminum wire in 120 volt circuits, used between 1964-1974. The arrow points to an overheated conductor which is a fire and safety hazard.

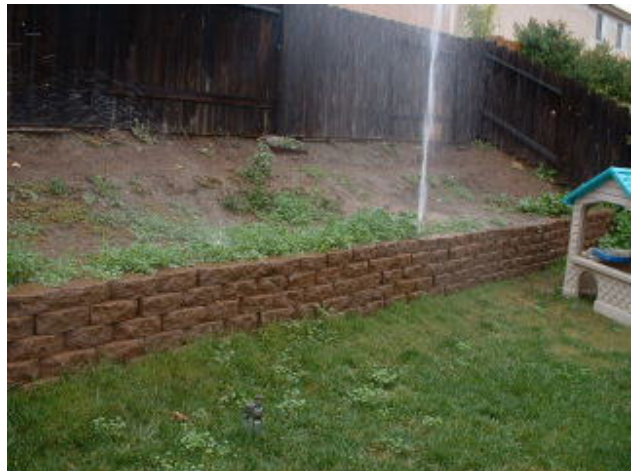
Broken Sprinkler head, causes "geyser". pressure loss does not allow other heads on the zone to function.

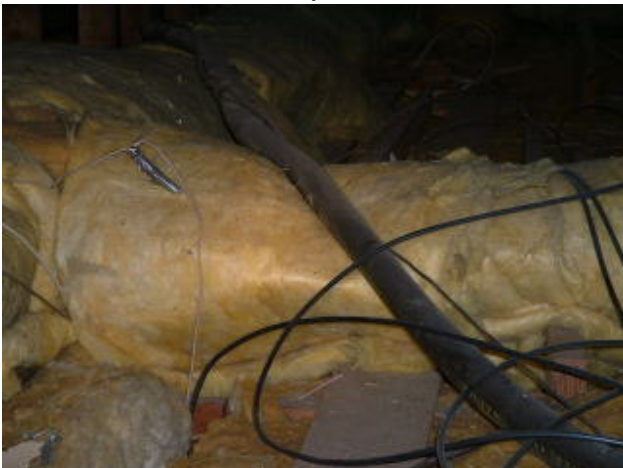
AC Refrigerant line set in attic was routed across and crushed Asbestos air duct.

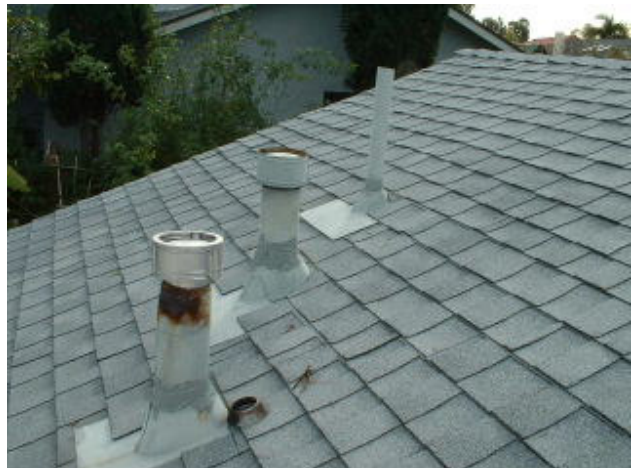
Furnace vent was nearly corroded through. // Storm collar was off of plumbing vent stack. Heater vents missing storm collars. // Cement Asbestos (Transite) water heater vent in middle.

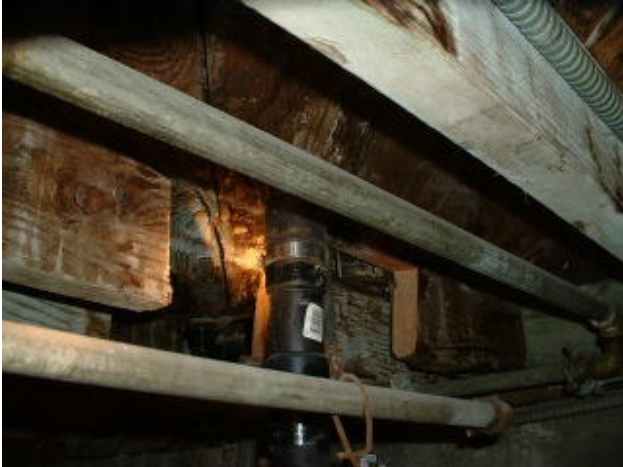
Moisture & mold damage unrepaired under bathroom. Old Galvanized plumbing present. Several Structural floor joists were inappropriately cut away.

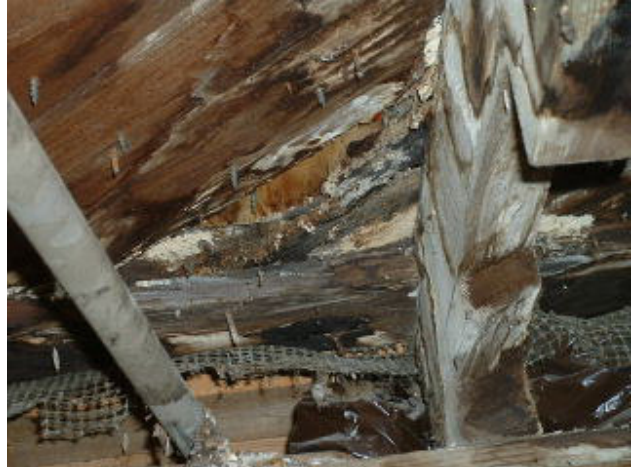
Mold damage under bathroom. Joist was cut away. Pest screen at crawlspace vent was damaged where pipe was run through.

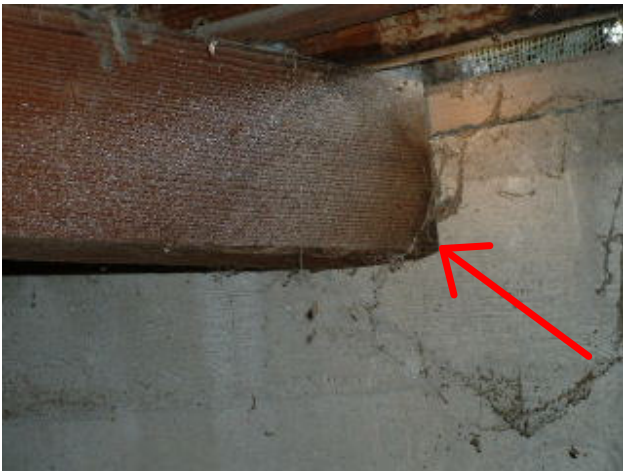
No Beam pocket molded into foundation wall. A main beam was left unsupported and not stabilized at this end.
